# Manhole Inspection Summary

Manhole # S31S1\_031MH

Insp Date: **2/18/08 10:45 AM**

**Location** Address: **801 Seagull Ave**

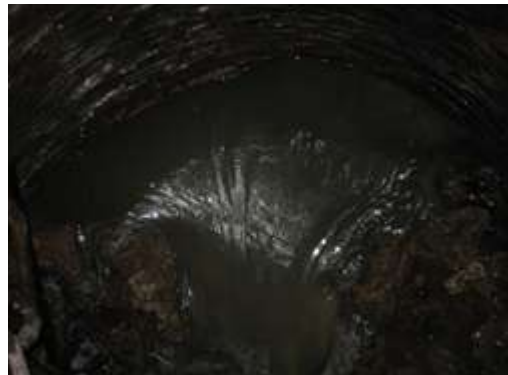
Defect 2

Condition: ☐ Sound ☐ Cracked ☐ Root Intrusion ☐ Deteriorated ☐ Leaks ☒ **Debris**

Channel

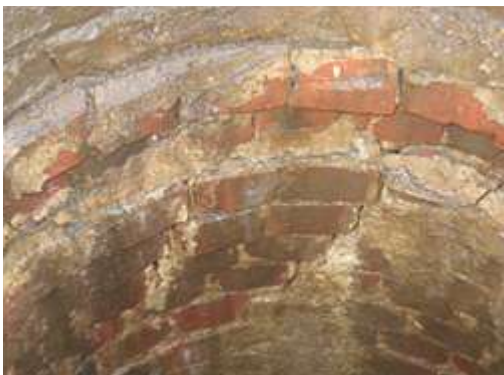
Defect 1

Infiltration: ☐ None ☒ **Joint** ☒ **Cracks** ☒ **Mortar** ☐ Roots ☒ **Wall**

Infiltration

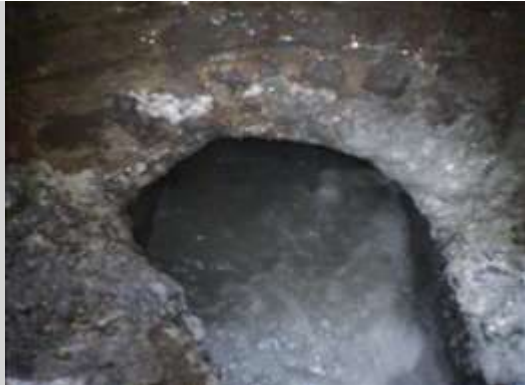
12 O'Clock Outflow

18 in. Circular Gravity Sewer  
Pipe Out @ 12 O'Clock

Pipe Height: **20.4** (in.) Rod and Bar (Angled)  
Pipe Material: **Clay** ☐ Pipe Lined  
Invert Depth: **15.49** (ft.) Flow Characteristics: **Fast**  
Deposits: ☒ None ☐ Mud ☐ Sludge ☐ Debris ☐ Grease  
Silt Depth: (in.) Deposits Extent:  
Infiltration: **None** Pipe Seal Cond: **Sound**

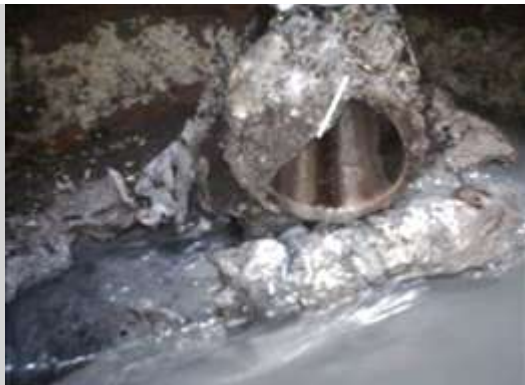
5 O'Clock Inflow

8 in. Circular Gravity Sewer  
Pipe In @ 5 O'Clock

Pipe Height: **8.4** (in.) Rod and Bar (Angled)  
Pipe Material: **Clay** ☐ Pipe Lined  
Invert Depth: **13.80** (ft.) Flow Characteristics: **None**  
Deposits: ☒ None ☐ Mud ☐ Sludge ☐ Debris ☐ Grease  
Silt Depth: (in.) Deposits Extent:  
Infiltration: **None** Pipe Seal Cond: **Sound**

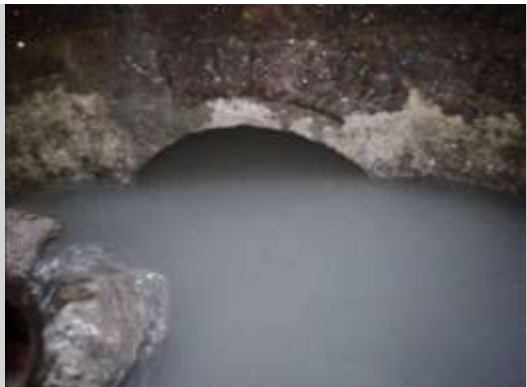
6 O'Clock Inflow

18 in. Circular Gravity Sewer  
Pipe In @ 6 O'Clock

Pipe Height: **19.2** (in.) Rod and Bar (Angled)  
Pipe Material: **Clay** ☐ Pipe Lined  
Invert Depth: **15.15** (ft.) Flow Characteristics: **Fast**  
Deposits: ☒ None ☐ Mud ☐ Sludge ☐ Debris ☐ Grease  
Silt Depth: (in.) Deposits Extent:  
Infiltration: **None** Pipe Seal Cond: **Sound**
